Mr. & Mrs. Thomas  
3718 W. Dravus St.  
Seattle, WA 98199

Saturday, February 25, 2006

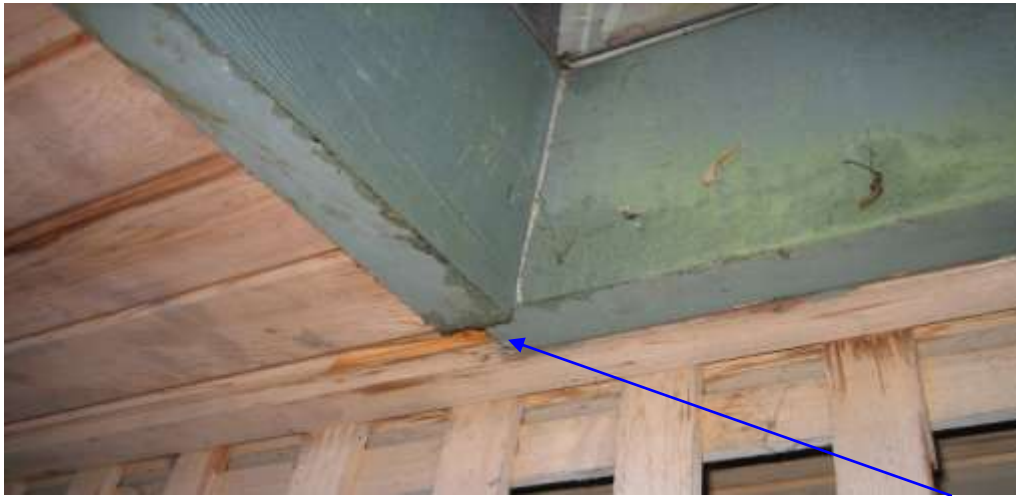
**Figure 1:** The damaged sheathing material is located directly behind the lowest trim board on the deck structure.

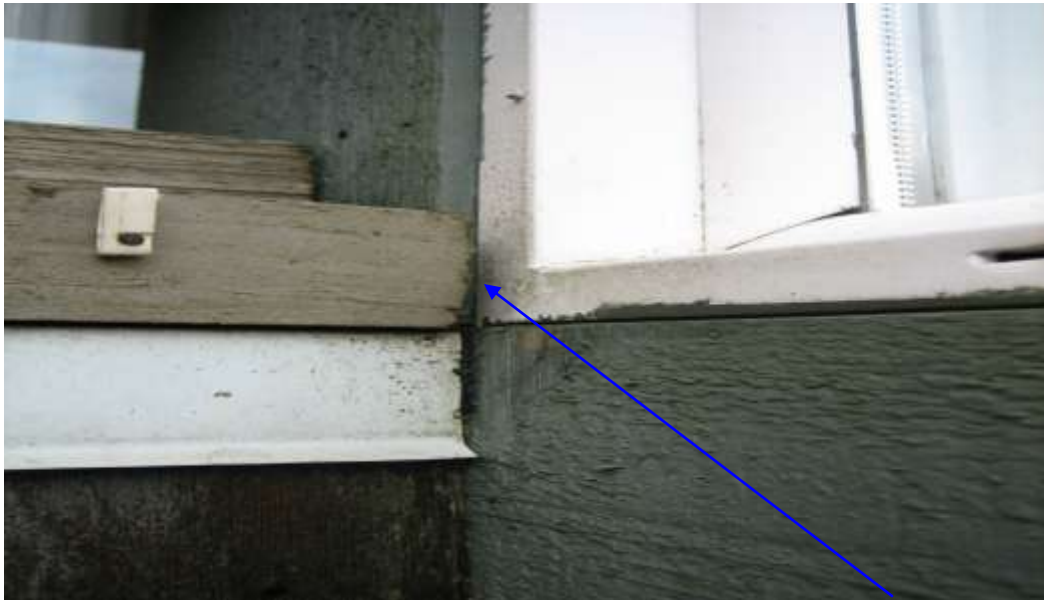
**Figure 2:** The deck rail system is installed directly adjacent to the window framing. This creates a void at the top of the rail system that could, over time allow water migration into the wall system.

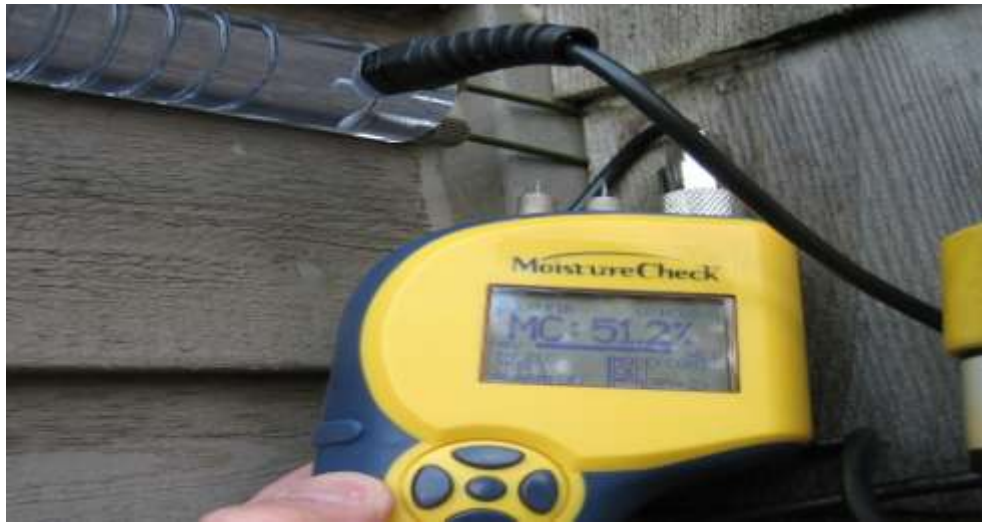
**Figure 3:** The only area of high moisture content related to the deck rail cap joint was at the lower south side deck. This is the deck with the most exposure to driven rain. Minor damage to the sheathing material was noted in the area.

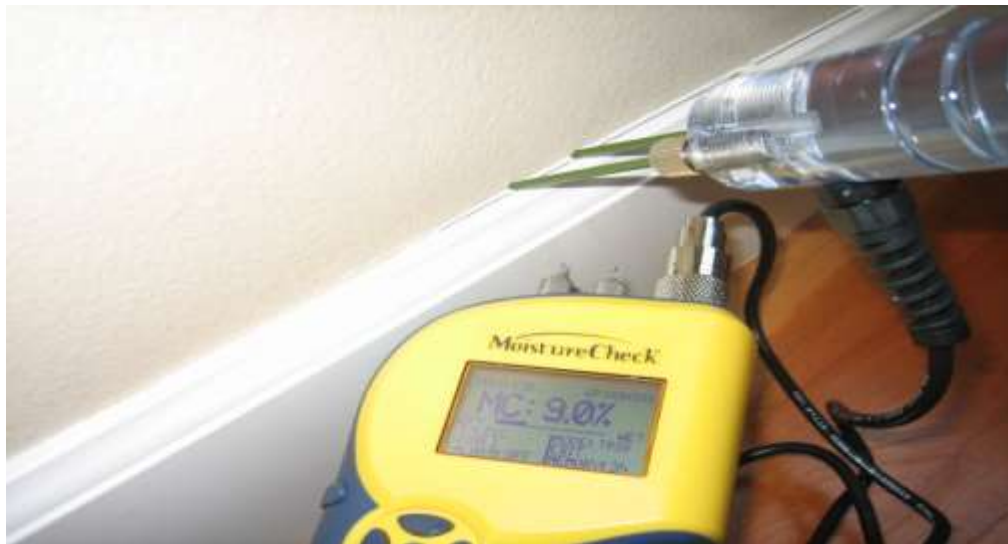
**Figure 4:** This deep wall probe is inserted directly inside and below, at the sill plate, the probe in the photo above. The 9% MC reading confirms that the moisture from deck rail outside has not entered the wall cavity.

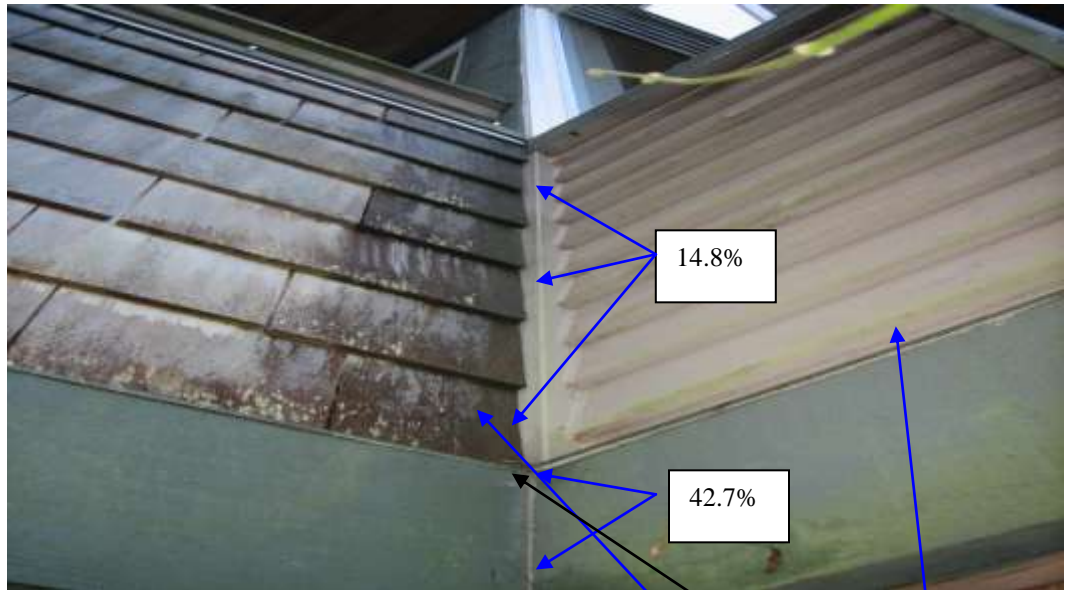
**Figure 5:** This photo shows the moisture readings at the south corner of the first floor north side deck. The moisture readings confirm that the water migration damage to the sheathing material was caused by the faulty drip cap flashing at the top of the trim board not by water migration into the wall system from the rail cap or sidewall connection above. The heavy mildew growth at the sidewall shakes and bevel board siding appears to be from a lack of direct sun on this wall so the wall does not dry not from excessive runoff at the rail cap.

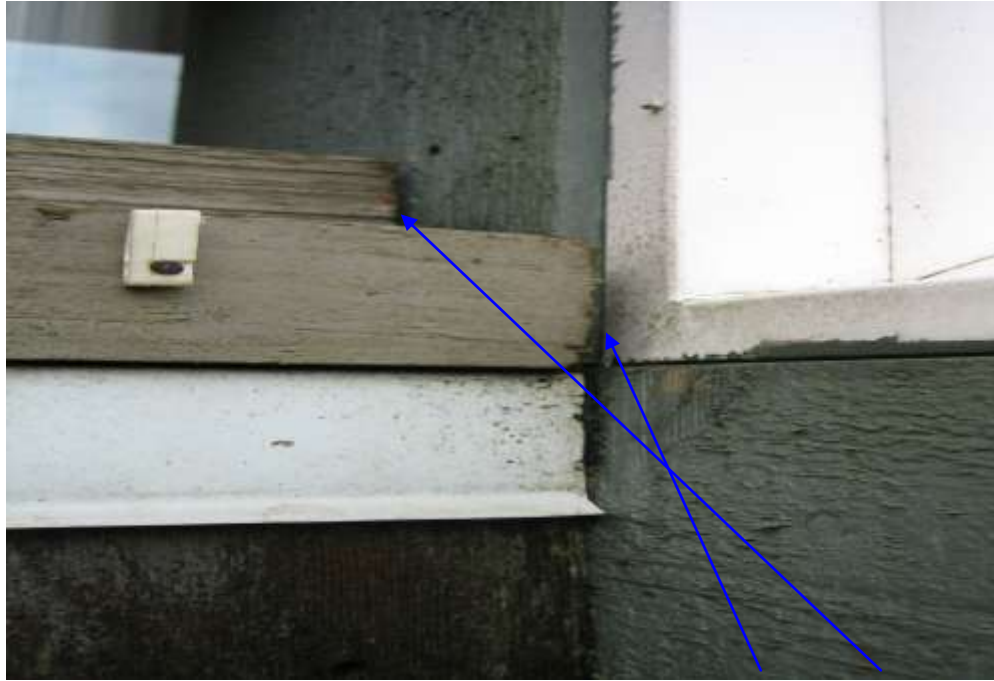
**Figure 6: The most critical caulking joint is at the deck rail to window and sidewall all decks. This area should be filled with a commercial grade caulking material.**
