Ms. Diane Keller
The Parkwood Condominiums
233 SW 154th St.
Burien, WA 98166

Friday, November 06, 2009

RE: Roofing Analysis for 233 SW 154th St, Burien, WA.

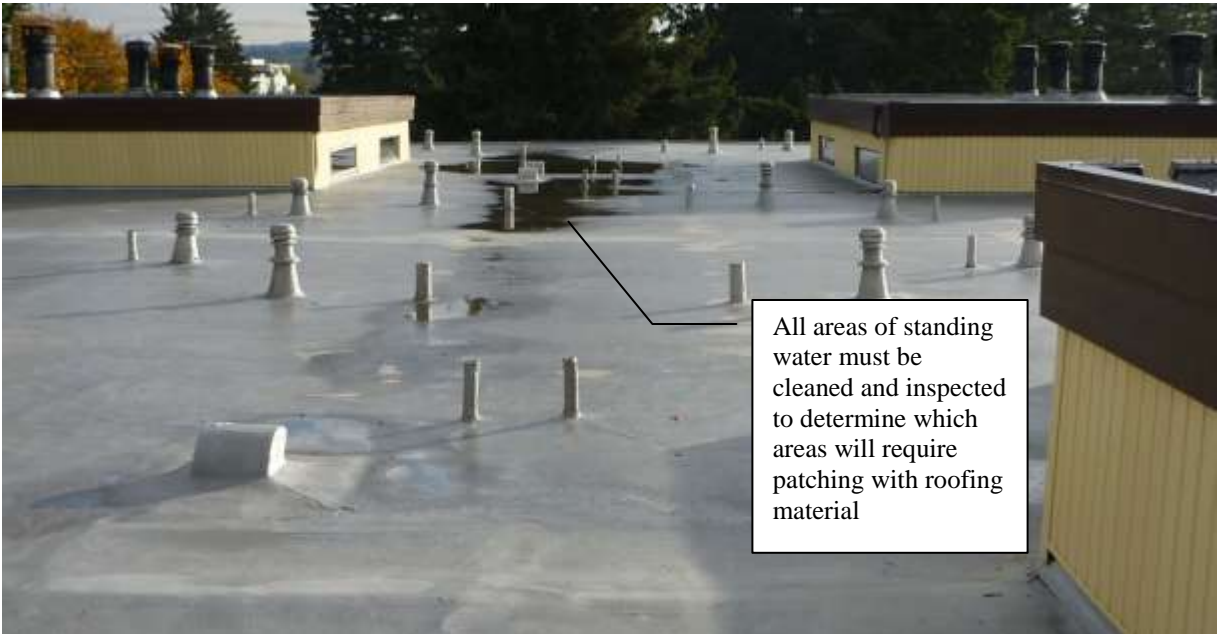
All areas of standing water must be cleaned and inspected to determine which areas will require patching with roofing material

- 1. All failed roofing areas a noted above and as located by the roofing contractor must be repaired or replaced as is found to be required.**
- 2. All areas of active leaks as located must be repaired as found to be required by the roofing contractor.**
- 3. Remove all standing water from the roof and located and properly repair any failing roofing material including all previous areas of patching.**
- 4. Locate and repair all localized areas of roofing failure.**
- 5. Seal all roof penetrations including all waste stacks, chimneys, vent, etc.**
- 6. Complete all repairs as located in the diagram above.**
- 7. Repair the damaged cap flashing at unit 310.**
- 8. Complete any other repairs required to stop all active leaks as found to be required by the roofing contractor.**
- 9. Complete all repairs required at all chimney / roof penetrations to ensure all active leaks are repairs.**

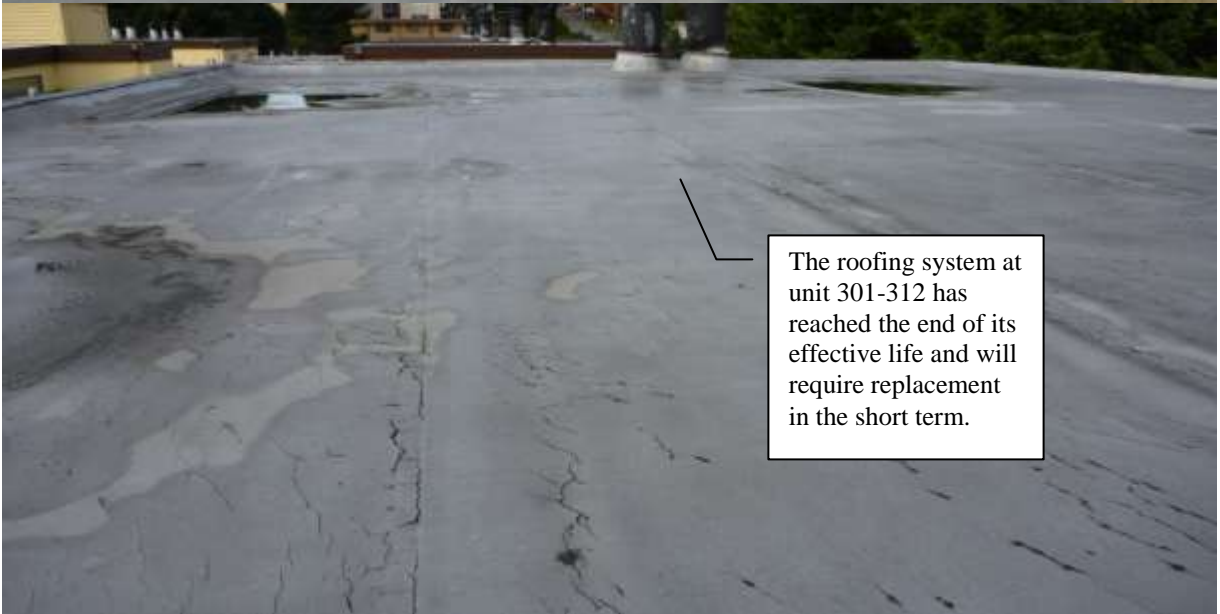
The roofing system at unit 301-312 has reached the end of its effective life and will require replacement in the short term.

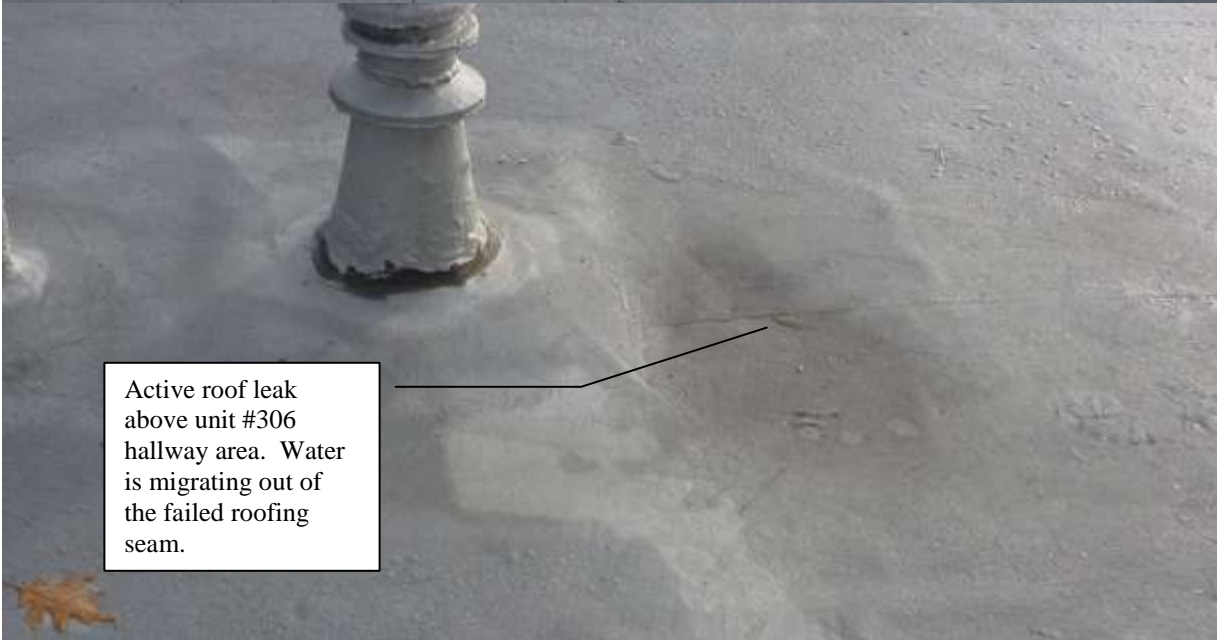
Active roof leak above unit #306 hallway area. Water is migrating out of the failed roofing seam.

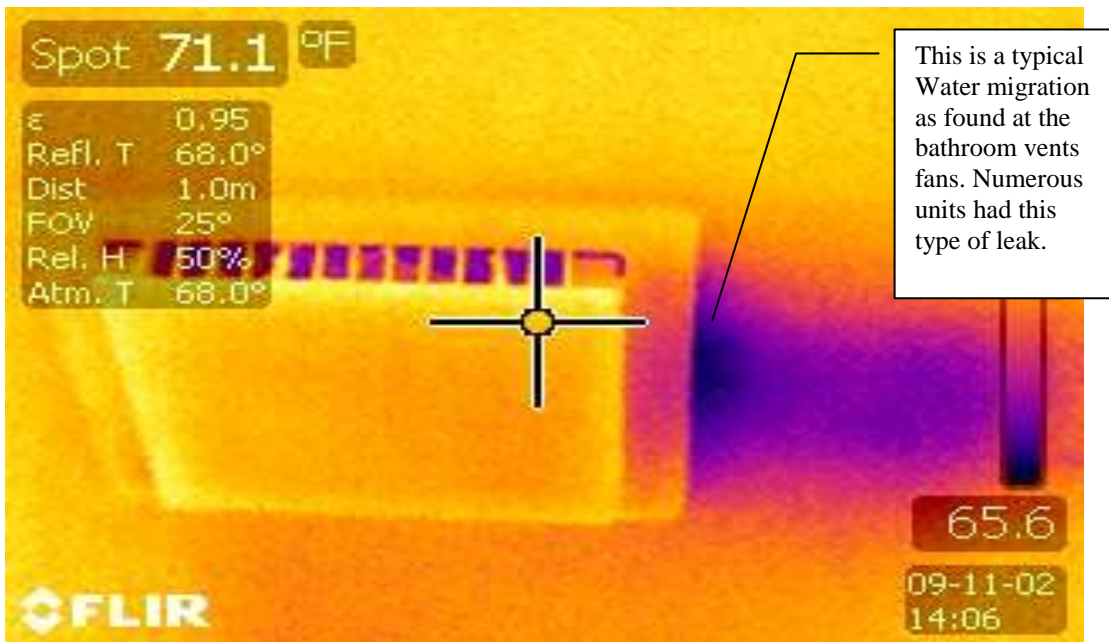
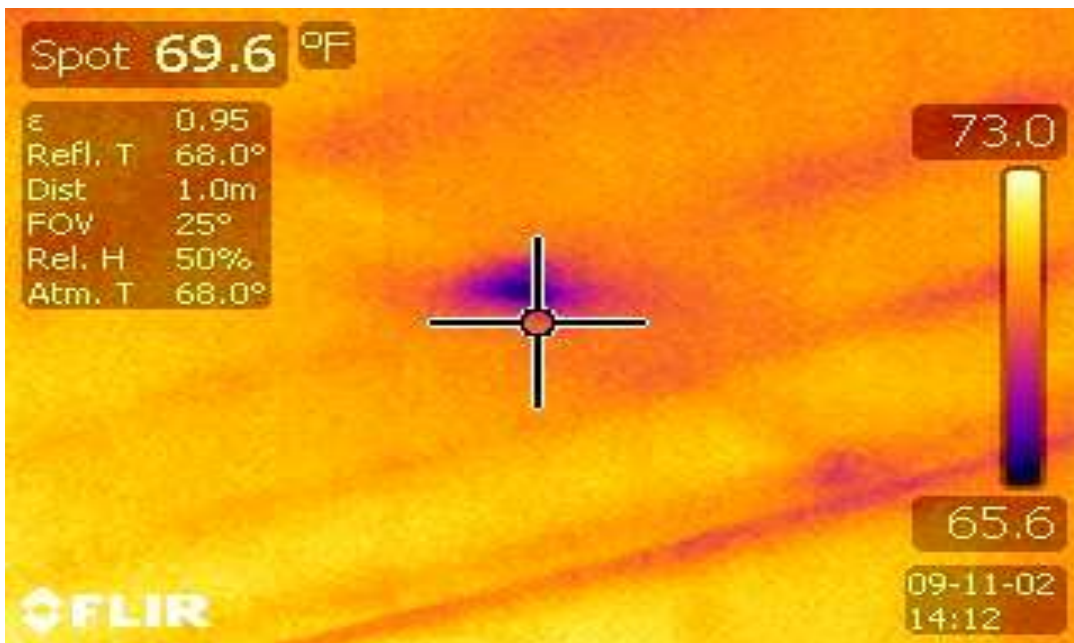
Limited areas of roofing failure and water migration were found throughout the building as shown below in the infrared thermographs and in the drawing outlining the specific areas of water migration.

Most of the areas of concern are small enough in area and have very limited areas of minor water migration and do not require removing any finish work unless further damage is found during the roof surface repairs.

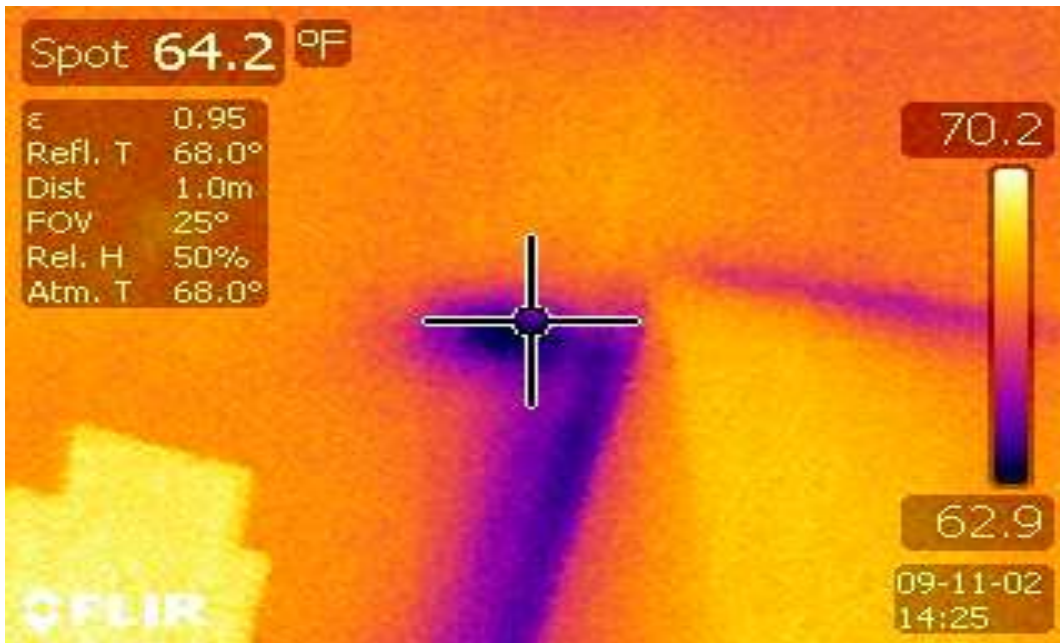
The areas of the interior finish work that show signs of water migration were generally very small, in the two to three inch diameter range. The specific areas are shown in the diagram below.

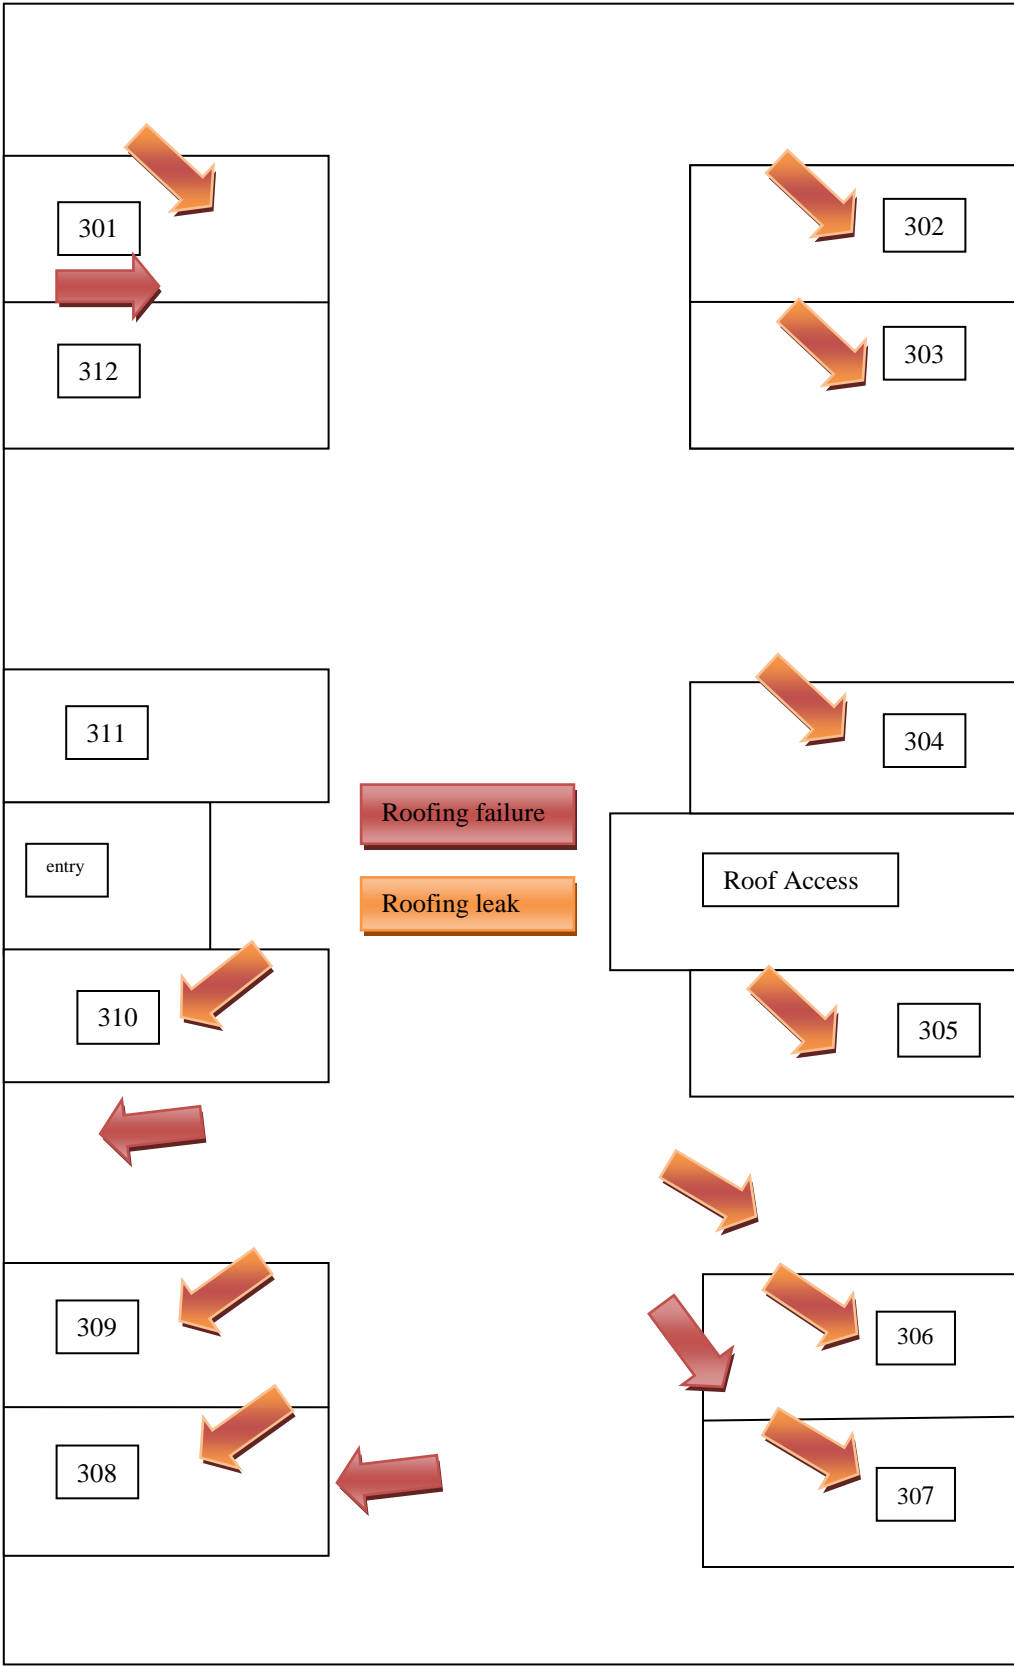
The areas around the chimneys at units 301, 312, 302 were found. See corrective actions listed in this report for the repairs required.

Unit # 306: Location of damage	ACTIVE
Unit # 306: Bedroom hallway/bathroom fan	ACTIVE
Unit # 301: SW corner of living room/to the right of bath fan	ACTIVE
Unit # 302: N side of chimney chase	ACTIVE
Unit # 303: Along chimney chase/center of living room/hallway near smoke detector/bedroom hall	ACTIVE
Unit # 304: Hallway	ACTIVE
Unit # 305: Bathroom fan	ACTIVE
Unit # 310: Hallway near smoke detector/in front of the master closet	ACTIVE
Unit # 309: Bedroom hallway	ACTIVE
Unit # 308: Bedroom hallway	ACTIVE
Unit # 307: Hallway near smoke detector	ACTIVE
