Ms. Diane Keller
The Parkwood Condominiums
233 SW 154th St.
Burien, WA 98166

Friday, November 06, 2009

RE: Roofing Analysis for 233 SW 154th St, Burien, WA.

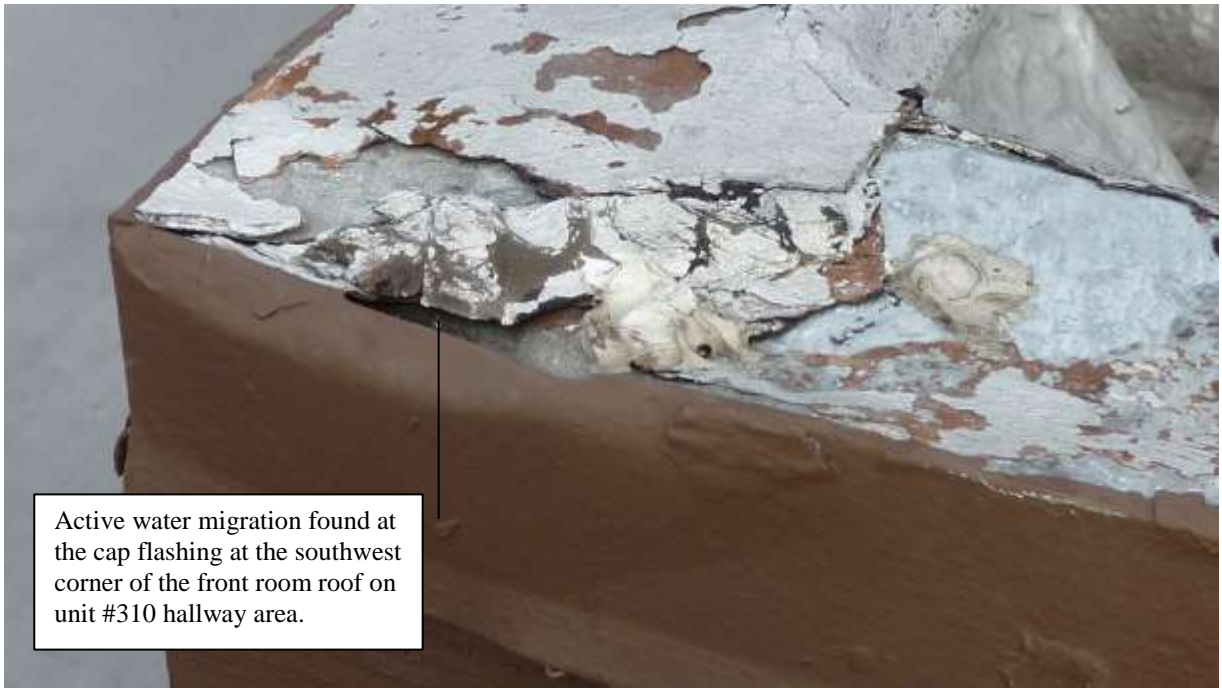
Active roof leak above unit #306 hallway area. Water is migrating out of the failed roofing seam.

- 1. All failed roofing areas a noted above and as located by the roofing contractor must be repaired or replaced as is found to be required.**
- 2. All areas of active leaks as located must be repaired as found to be required by the roofing contractor.**
- 3. Remove all standing water from the roof and located and properly repair any failing roofing material including all previous areas of patching.**
- 4. Locate and repair all localized areas of roofing failure.**
- 5. Seal all roof penetrations including all waste stacks, chimneys, vent, etc.**
- 6. Complete all repairs as located in the diagram above.**
- 7. Repair the damaged cap flashing at unit 310.**
- 8. Complete any other repairs required to stop all active leaks as found to be required by the roofing contractor.**
- 9. Complete all repairs required at all chimney / roof penetrations to ensure all active leaks are repairs.**
